MANAHAWKIN LAKE DAM

NJ 00057

PHASE 1 INSPECTION REPORT NATIONAL DAM SAFETY PROGRAM

PHASE I REPORT
NATIONAL DAM SAFETY PROGRAM

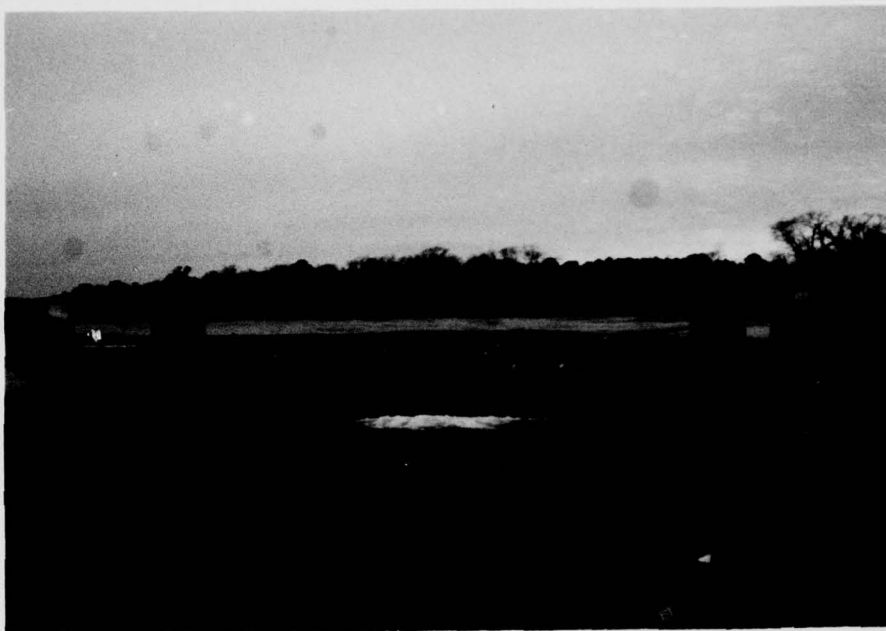
PHOTO 1
SPILLWAY

primary (elev. 23.6) crest of the spillway and, therefore, the condition of much of the spillway surface was not clearly observed. In the sections of the spillway that were dry, some eroding of the concrete surface was observed. In general, however, all concrete appeared to be in good condition.

Aligned true to plans. Surface of weir and downstream face eroded; aggregate somewhat exposed. No cracks or spalls observed.

- a. Drain the lake to an elevation equal to the invert of the outlet pipe.
- b. Sand blast all concrete, pressure grout any major cracks and patch all spalls and eroded surfaces.
- c. Apply an epoxy preservative coating to all surfaces.

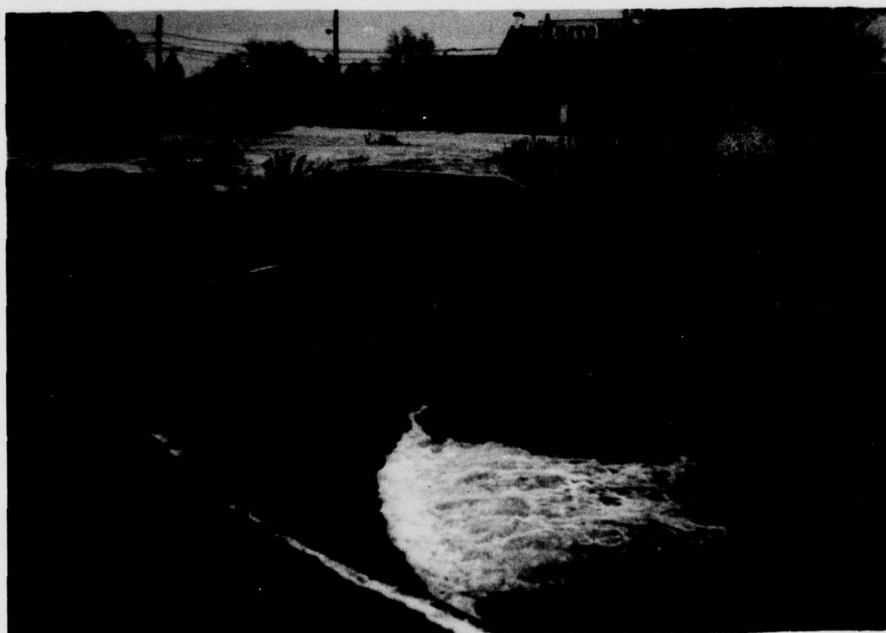
PHOTO 2
CONCRETE MANHOLE FOR SLIDE GATE,
OUTLET PIPE IN SPILLWAY DOWNSTREAM FACE,

Reportedly, the outlet equipment is in good working condition, although its operation was not observed at the time of inspection. The 30-inch diameter CM pipes were observed at their outlet ends and appeared to be in good condition. The manholes housing the outlet gates were observed to be in good condition.

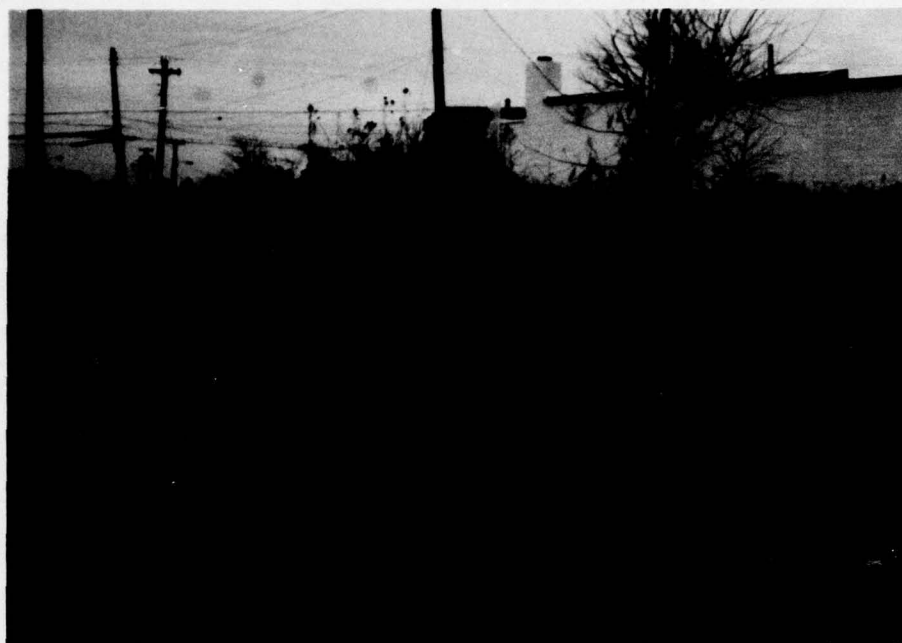
PHOTO 9

BULKHEAD ALONG EAST SIDE
OF DOWNSTREAM CHANNEL
